# Nissan 300Z | 1990 Car Radio Removal

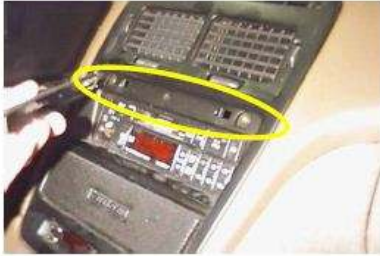
**STEP 1:**

To remove the radio, the plastic dash panel surrounding the radio must be removed. Directly above the radio is a plastic cover snapped into the plastic dash panel. This plastic cover (approximately 7" x 3/4") has a snap at each end. With a flat head screwdriver, pry up the plastic cover at one end until it unsnaps from the plastic dash panel.

Locate and remove two (2) phillips screws that were hidden under the plastic cover.

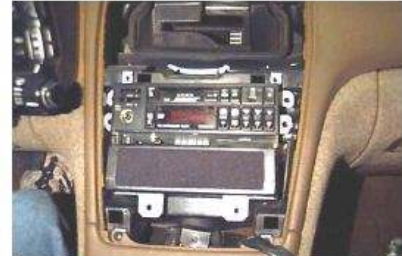
**STEP 3:**

When all 4 screws have been removed, the dash plastic dash panel can be pulled from the center of the dash. Pull the dash off. You will notice that the bottom of the dash has wires attached to the rear of the digital clock mounted to the bottom of the plastic dash panel. You do not have to disconnect the wires attached to the clock so you can set the plastic dash panel off to the passenger side of the dash and leave the plastic dash panel hanging by the wires attached to the clock.

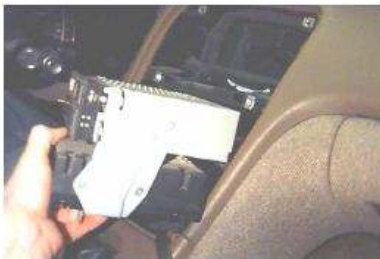
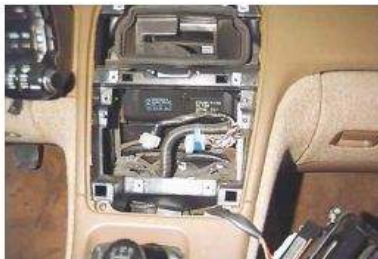
**STEP 4:**

The radio is attached to either a pocket below the radio or a speaker box located in the same location by metal brackets on each side of the radio/pocket assembly. To remove the radio you will have to remove the screws that secure the metal brackets to the dash. Locate and remove six (6) phillips screws securing the metal brackets to the dash (2 below the pocket/speaker and 4 secure the sides of the radio - 2 on each side of the radio).

Once all 6 screws have been removed, pull the radio/pocket assembly out of the dash.

Unplug the black plastic cable plugged into the rear of the Nissan radio. Unplug 2 white connectors plugged into the rear of the Nissan radio. Unplug any other connectors attached to the radio/pocket assembly. The radio should now be able to be completely removed from the vehicle.
