Nissan Maxima | 1994-1997

Car Radio Removal

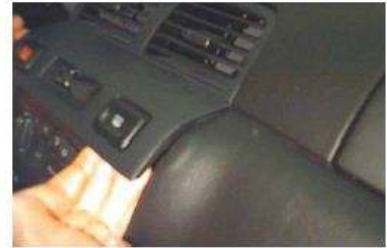
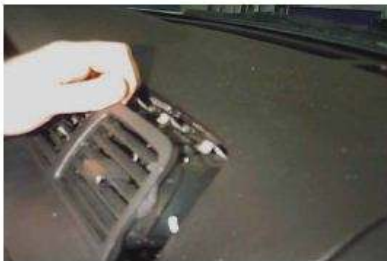
STEP 1:

Located directly above the air conditioner controls is a contoured plastic panel which contains the clock, hazard switch, defrost switch, and center dash air conditioner vents. This panel must be removed. This panel is snapped into the dash and is difficult to remove.

The Install Doctor recommends using a **flat head screwdriver** to unsnap this panel. Insert the tip of the flat head screwdriver between the lower right corner of the plastic contoured dash panel and the softer dash board. **SLOWLY**, pry the panel up. Continue this with all 4 corners of the contoured panel until it begins to unsnap and free from the main dash board assembly.

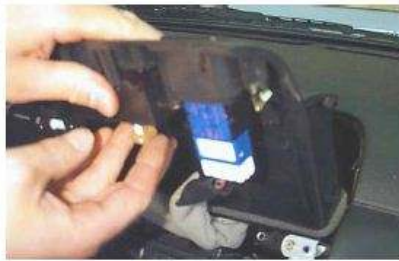
STEP 2:

Once the contoured plastic dash panel has loosened from the dash, grab the top of the panel (above the air vents) and pull firmly until the panel completely separates from the dash.

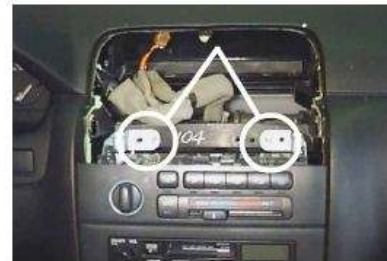
STEP 4:

Now that the upper dash panel has been completely removed, you will be able to see the screws that secure the top of the radio/air conditioner assembly.

Locate and remove two (2) **Phillips screws** (as seen in the photo above).

(as seen in photo for STEP 4)

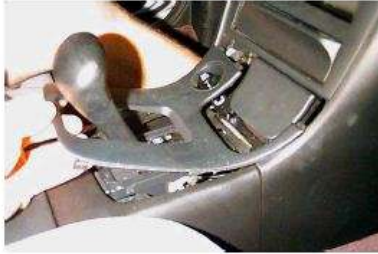
STEP 5:

Move to the gear shift area. Surrounding the gear shift is a plastic panel which needs to be removed. This panel simply unsnaps from the center console. With your hands, pull one of the corners up to unsnap the lower part of this plastic panel. If you need assistance lifting up an edge, use a small flat head screwdriver and insert the tip between an edge in the plastic panel and the center dash console. If your vehicle has a standard transmission, the gear shift knob will unscrew and the leather cover should slide off.

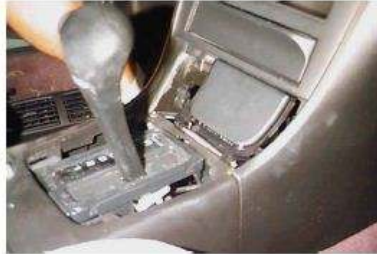
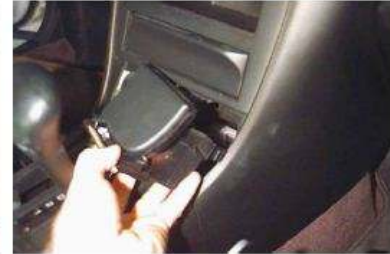
Once the lower edges have been lifted up, pull the plastic panel towards the rear. The upper part of the plastic panel extends up, on each side of the ashtray. Pull the plastic panel until it completely separates from the center dash console. Unplug the plastic wire connector attached to the rear of the cigarette lighter.

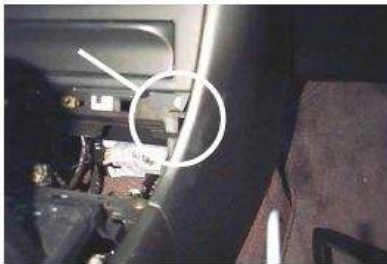
STEP 7:

After the ashtray has been removed, the screws securing the lower right part of the radio/air conditioner assembly can be seen.

Locate and remove one (1) phillips screw that was hidden behind the ashtray.

Locate and remove one (1) phillips screw on the opposite corner securing the lower left part of the radio/air conditioner assembly.

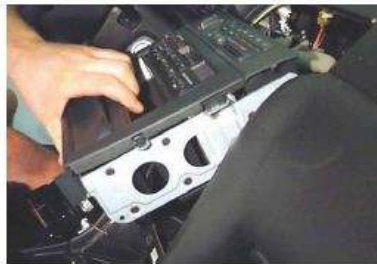
STEP 8:

All screws needed to remove the radio/air conditioner assembly have now been removed.

As seen in the photo above, pull the lower part of the radio/air conditioner assembly, then the upper part until the assembly pulls out of the dash.

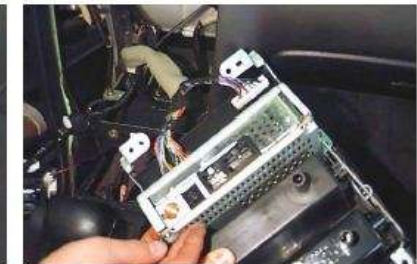
STEP 9:

With the radio/air conditioner assembly pulled from the dash, turn the assembly so you can see the rear where the wiring is located.

Unplug the black cable connected to the rear of the radio. Unplug two (2) plastic connectors plugged into the rear of the radio.

Unplug three (3) connectors plugged into the rear of the air conditioner controls.

Unplug any other connectors plugged into any other accessory attached to the radio/air conditioner assembly.

The radio/air conditioner assembly can now be completely removed from the dash.

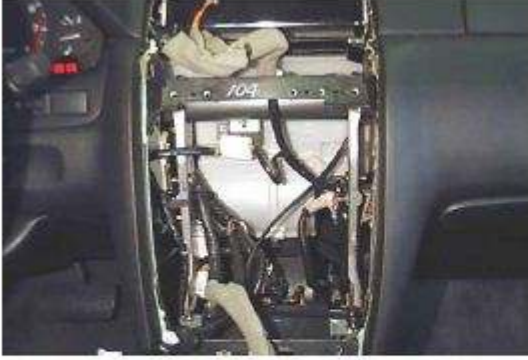
Photo after radio/air conditioner assembly has been completely removed from the dash.

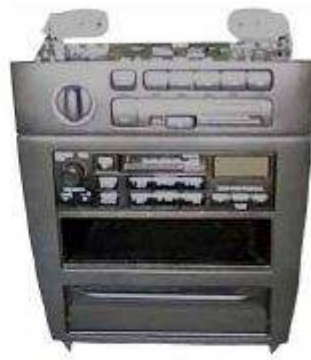
Photo of the radio/air conditioner assembly after being removed from the vehicle.
