Nissan Sentra | 1991-1996

Car Radio Removal

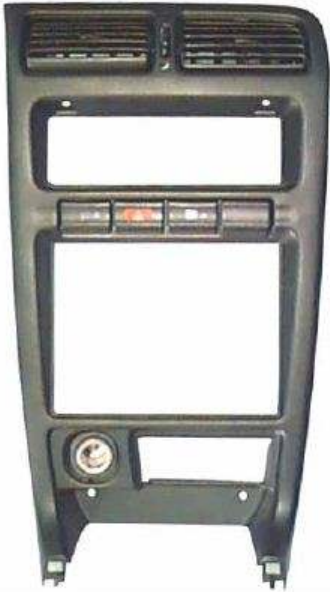
The entire plastic dash panel surrounding the radio must be removed in order to remove the radio in this vehicle.

Move to the drivers side of the dash. You will need to look under the dash, below the steering wheel. Look on the side wall of the plastic dash panel shown above. If you look UP behind the radio, you will notice a BLACK CABLE running down from the radio area. This is the cable that is attached to the air conditioner air flow regulator dial at the top of the plastic dash panel.

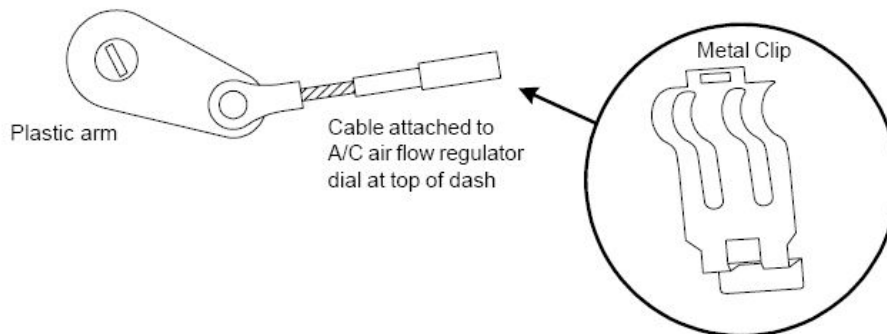
Look at the diagram below. The end of the cable has a round ring connector attached to it which connects to a plastic white or off-white colored arm. You will need to SLIDE OFF the ring connector from the plastic arm. But, to prevent the cable from moving while driving and the ring connector from disconnecting on its own, Nissan added a black metal clip (seen in the circular diagram) to the cable to keep it stationary. This clip simply unclips. With your fingers or a flat head screwdriver, unsnap the bottom of the clip and it will "pop off". Once the clip is popped off, you will be able to slide off the ring connector away from the plastic arm and the cable will then be disconnected from the plastic arm.

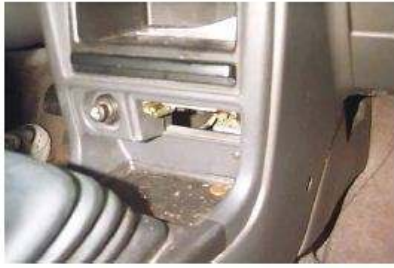
STEP 1:

Pull out the ashtray. Locate and remove two (2) phillips screws located below the ashtray and cigarette lighter.

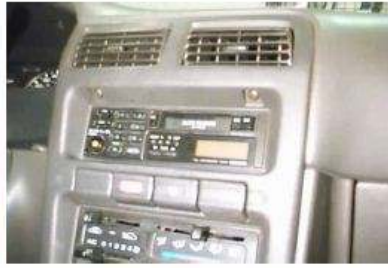
STEP 2:

Locate and remove two (2) phillips screws located directly above the radio.

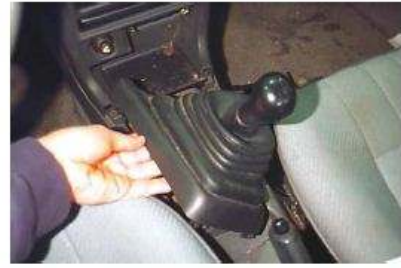
STEP 3:

You need to remove the plastic dash panel surrounding the gear shift area. This panel simply unsnaps by lifting it up with your hands.

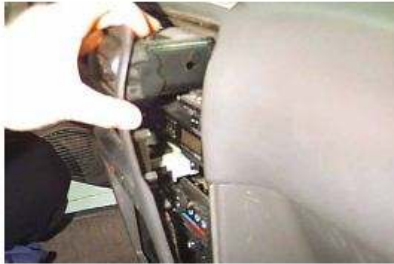
STEP 4:

The dash panel can now be pulled away from the main body of the dash. Grab the top of the dash panel with your hands and pull firmly.

WARNING: If you have a 92 with the air conditioner air flow limiter dial between the air vents, see the previous page regarding the cable attached to this dial.

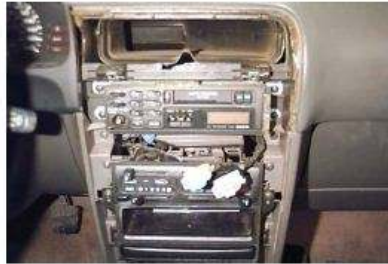
STEP 5:

Once the dash has been removed, the screws securing the radio can now be seen. Locate and remove four (4) phillips screws that secure the radios brackets to the dash.

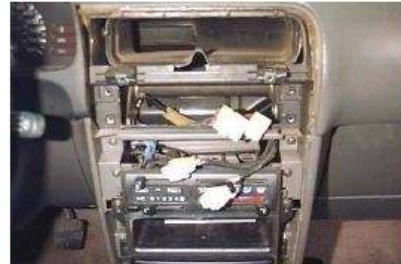
STEP 6:

Pull the radio out of the dash. Unplug the black cable plugged into the rear of the radio. Unplug 2 plastic wire harness connectors snapped into the rear of the radio.

Look at the black cable that was plugged into the rear of the radio. You will be able to tell if you need a "Nissan Antenna Adapter" by looking at this cable and turning to the next page.

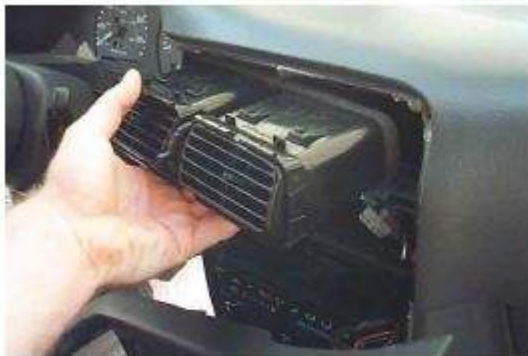
The air vents should always be attached to the plastic dash panel just removed. However, these air vents sometimes unsnap from the rear of the dash panel and remain in the dash. Pull out the air vents and reattach them back onto the rear of the dash panel. It will be nearly impossible for the air vents to reattach themselves when you reattach the plastic dash panel later. It is recommended that you reattach them now.
