Infiniti G-20 | 1991-1996 Car Radio Removal

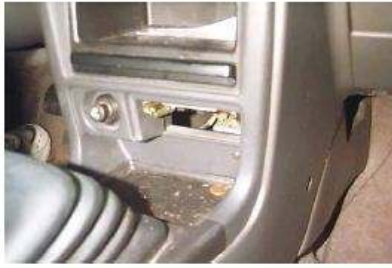
STEP 1:

Pull out the ashtray. Locate and remove two (2) phillips screws located below the ashtray and cigarette lighter.

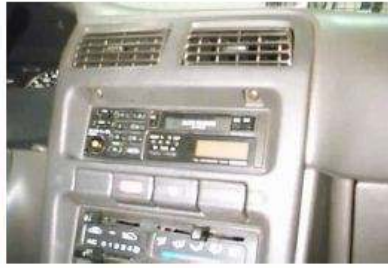
STEP 2:

Locate and remove two (2) phillips screws located directly above the radio.

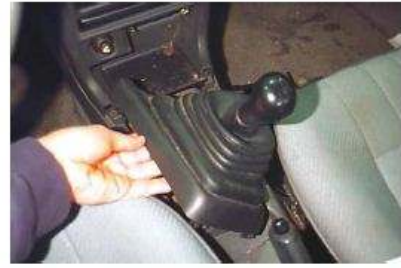
STEP 3:

You need to remove the plastic dash panel surrounding the gear shift area. This panel simply unsnaps by lifting it up with your hands.

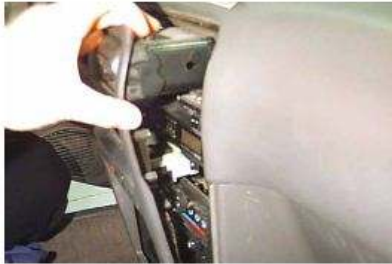
STEP 4:

The dash panel can now be pulled away from the main body of the dash. Grab the top of the dash panel with your hands and pull firmly.

WARNING: If you have a 92 with the air conditioner air flow limiter dial between the air vents, see the previous page regarding the cable attached to this dial.

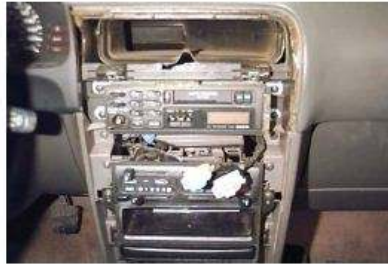
STEP 5:

Once the dash has been removed, the screws securing the radio can now be seen. Locate and remove four (4) phillips screws that secure the radios brackets to the dash.

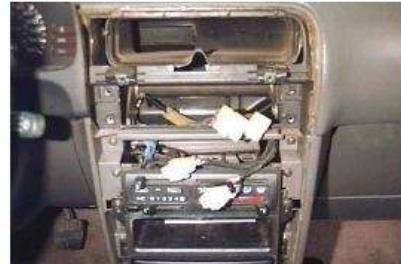
STEP 6:

Pull the radio out of the dash. Unplug the black cable plugged into the rear of the radio. Unplug 2 plastic wire harness connectors snapped into the rear of the radio.

Look at the black cable that was plugged into the rear of the radio. You will be able to tell if you need a "Nissan Antenna Adapter" by looking at this cable and turning to the next page.

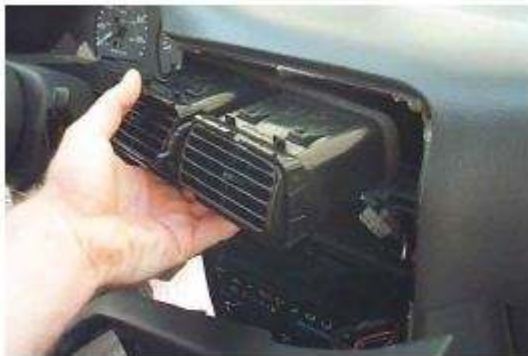
NOTE:

The air vents should always be attached to the plastic dash panel just removed. However, these air vents sometimes unsnap from the rear of the dash panel and remain in the dash. Pull out the air vents and reattach them back onto the rear of the dash panel. It will be nearly impossible for the air vents to reattach themselves when you reattach the plastic dash panel later. It is recommended that you reattach them now.
