## Infiniti G-20 | 1991-1996 Car Radio Removal

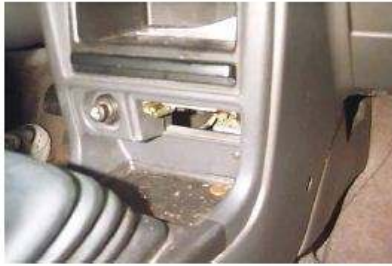
### STEP 1:

Pull out the ashtray. Locate and remove two (2) phillips screws located below the ashtray and cigarette lighter.

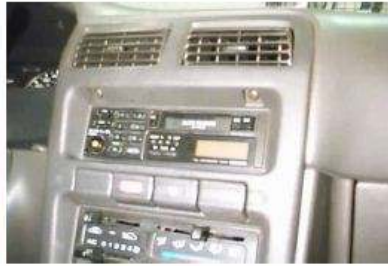
### STEP 2:

Locate and remove two (2) phillips screws located directly above the radio.

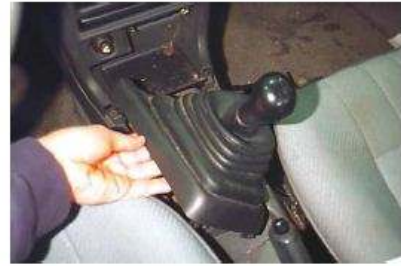
### STEP 3:

You need to remove the plastic dash panel surrounding the gear shift area. This panel simply unsnaps by lifting it up with your hands.

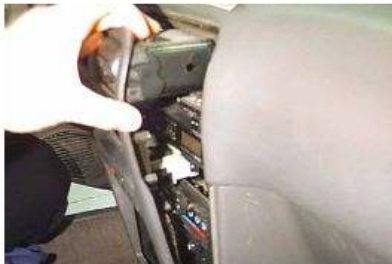
### STEP 4:

The dash panel can now be pulled away from the main body of the dash. Grab the top of the dash panel with your hands and pull firmly.

**WARNING:** If you have a 92 with the air conditioner air flow limiter dial between the air vents, see the previous page regarding the cable attached to this dial.

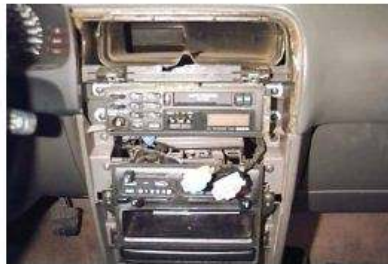
### STEP 5:

Once the dash has been removed, the screws securing the radio can now be seen. Locate and remove four (4) phillips screws that secure the radios brackets to the dash.

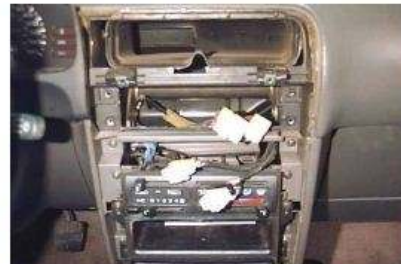
### STEP 6:

Pull the radio out of the dash. Unplug the black cable plugged into the rear of the radio. Unplug 2 plastic wire harness connectors snapped into the rear of the radio.

Look at the black cable that was plugged into the rear of the radio. You will be able to tell if you need a "Nissan Antenna Adapter" by looking at this cable and turning to the next page.
